**REBUILD ATLANTA  
ENERGY AUDITOR'S REPORT  
ATLANTA CENTER FOR EMPLOYMENT & TRAINING**

Prepared: August 9, 2004  
Prepared By: Cyrus Bhedwar, City of Atlanta  
Jeff Ross-Bain, Southface  
Corinne Benedek, Southface

**Atlanta Center for Employment & Training  
818 Washington Ave.  
Atlanta, Georgia 30303**

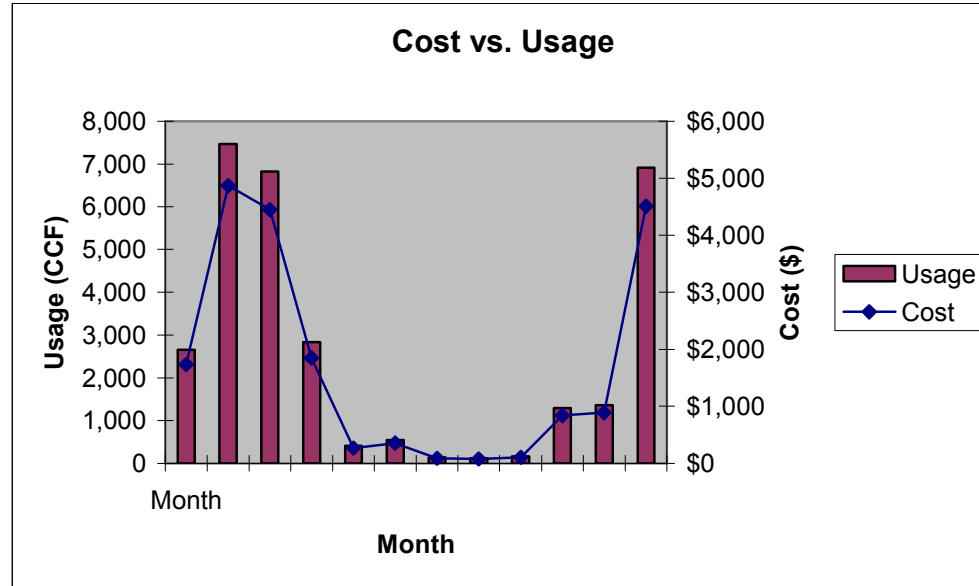
## Natural Gas Data

Month	CCF	Cost
Jan-02	2,657	\$1,732
Feb-02	7,461	\$4,865
Mar-02	6,822	\$4,448
Apr-02	2,832	\$1,847
May-02	410	\$267
Jun-02	546	\$356
Jul-02	137	\$89
Aug-02	113	\$74
Sep-02	161	\$105
Oct-02	1,290	\$841
Nov-02	1,357	\$885
Dec-02	6,911	\$4,506
<b>Total</b>	<b>30,697</b>	<b>\$20,016</b>
